**LAKE TORINO DAM**

**FRANKLIN COUNTY, MISSOURI**

**MO 30552**

**PHASE 1 INSPECTION REPORT  
NATIONAL DAM SAFETY PROGRAM**

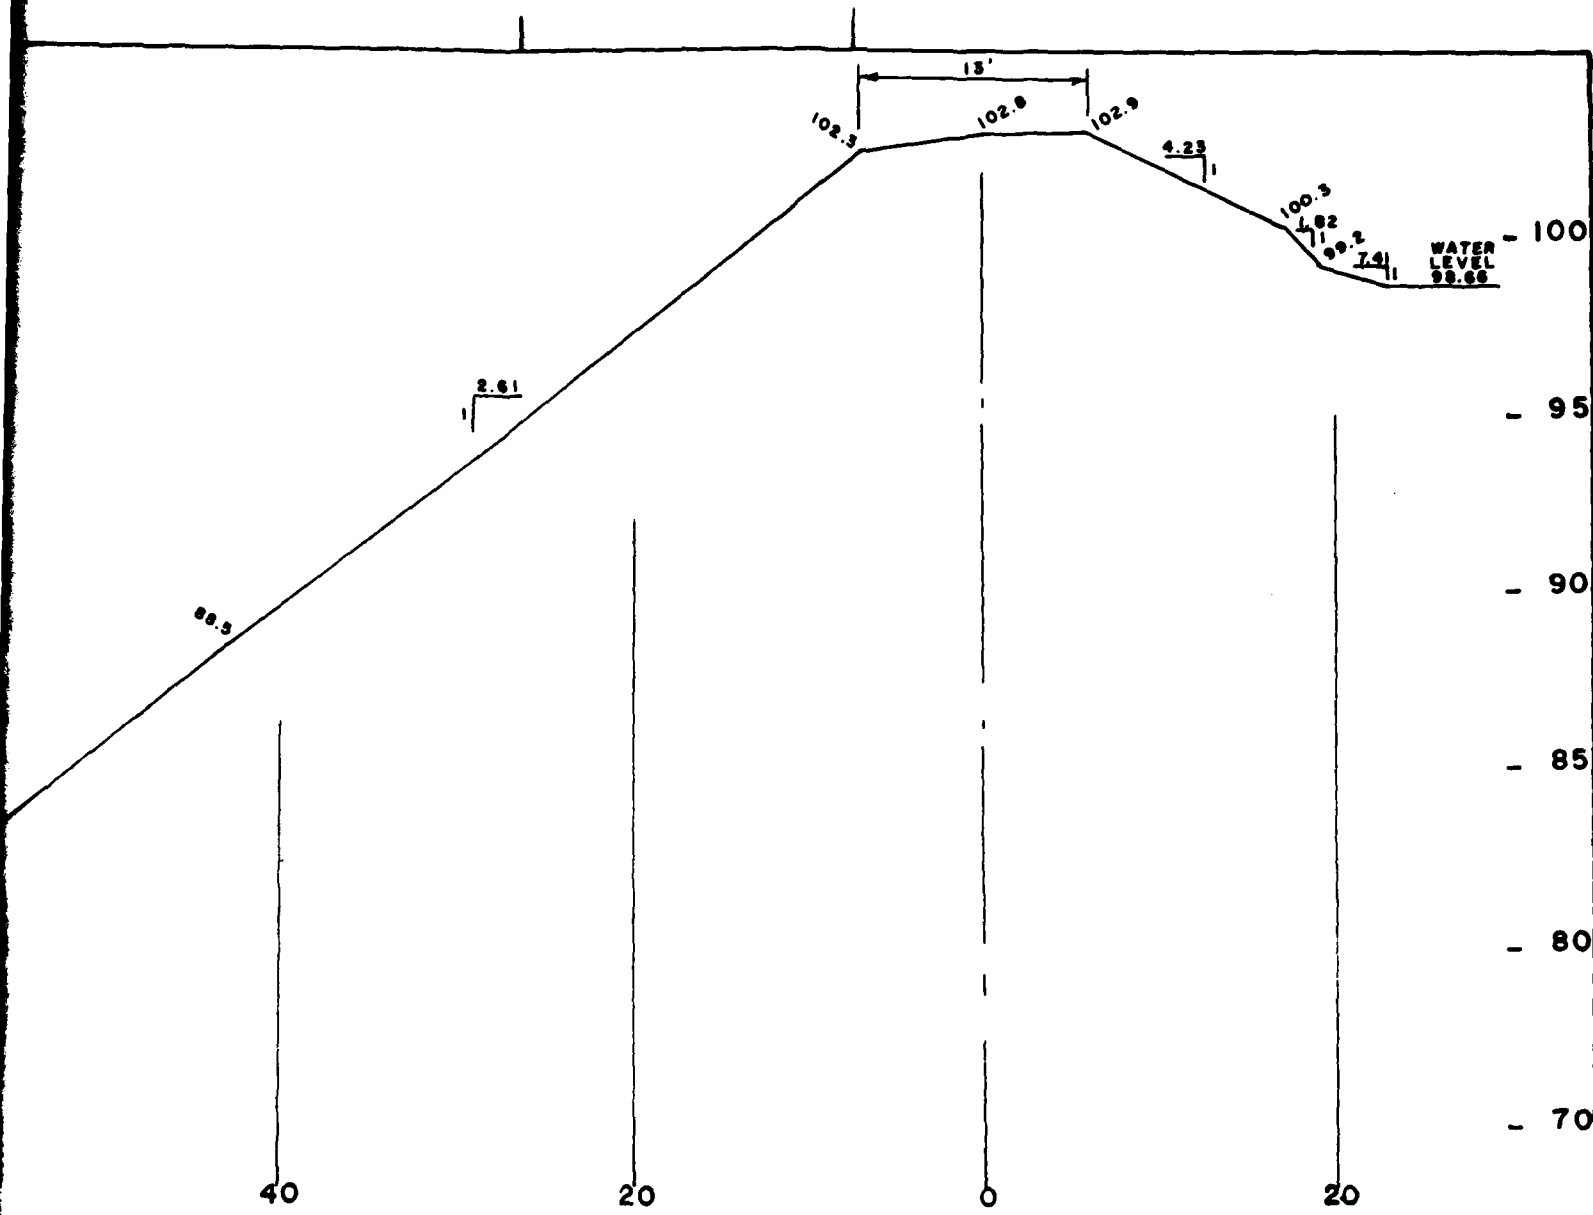
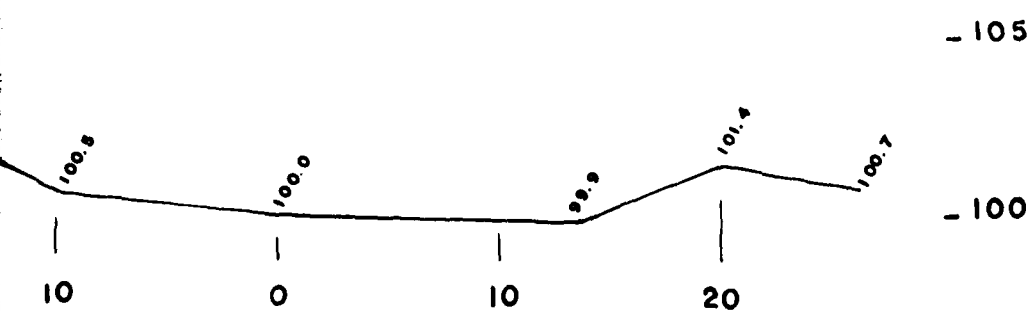
<p>ANDERSON ENGINEERING, INC.          730 NORTH BENTON AVENUE          SPRINGFIELD, MISSOURI 65802</p>
<p>LAKE TORINO DAM</p> <p>MO. No. 30552</p> <p><u>PLAN &amp; PROFILE</u></p>
<p>FRANKLIN COUNTY, MO.</p>

SECTION A-A STA 2+00

SECTION B-B 68' RT. STA 6+22
